# Manhole Inspection Summary

Manhole # S17II\_002MH

Insp Date: **6/12/07 7:48 AM**

**Location** Address: **2213 WESTWOOD AVE**

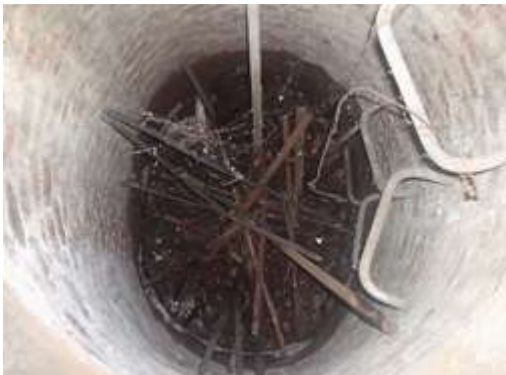
Defect 3

Condition: ☐ Sound ☐ Cracked ☐ Root Intrusion ☐ Deteriorated ☐ Leaks ☒ **Debris**

DEBRIS IN CHANNEL

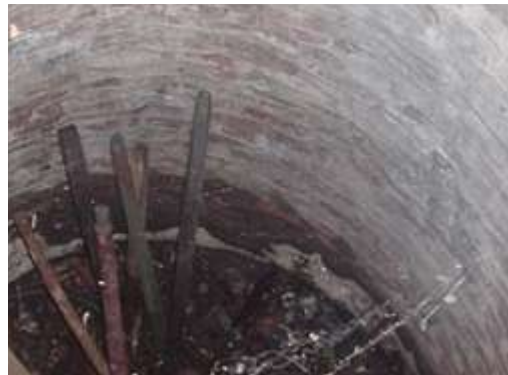
Defect 2

Infiltration: ☐ None ☐ Joint ☐ Cracks ☐ Mortar ☐ Roots ☒ **Wall**

INFILTRATION OF BARREL

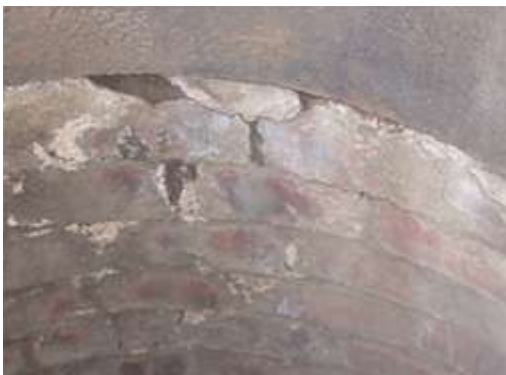
Defect 1

Condition: ☐ Sound ☐ Cracked ☐ Root Intrusion ☐ Loose Brick ☒ **Deteriorated**

DETERIORATION OF CHIMNEY

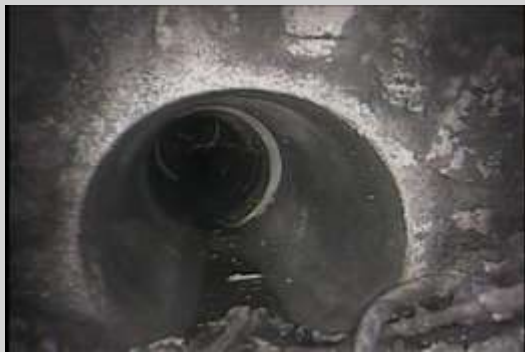
12 O'Clock Outflow

8 in. Circular Gravity Sewer  
Pipe Out @ 12 O'Clock

Deposits: ☐ None ☐ Mud ☐ Sludge ☒ **Debris** ☐ Grease

Silt Depth: **2** (in.) Deposits Extent: **Light**
